COMPLAINT MEDIATION CASE STUDY

MICHAEL COLOZZI / JEFFREY LOCKE
FIELD OPERATIONS AND ENFORCEMENT DIVISION
BAR ADVISORY GROUP MEETING
JANUARY 26, 2023

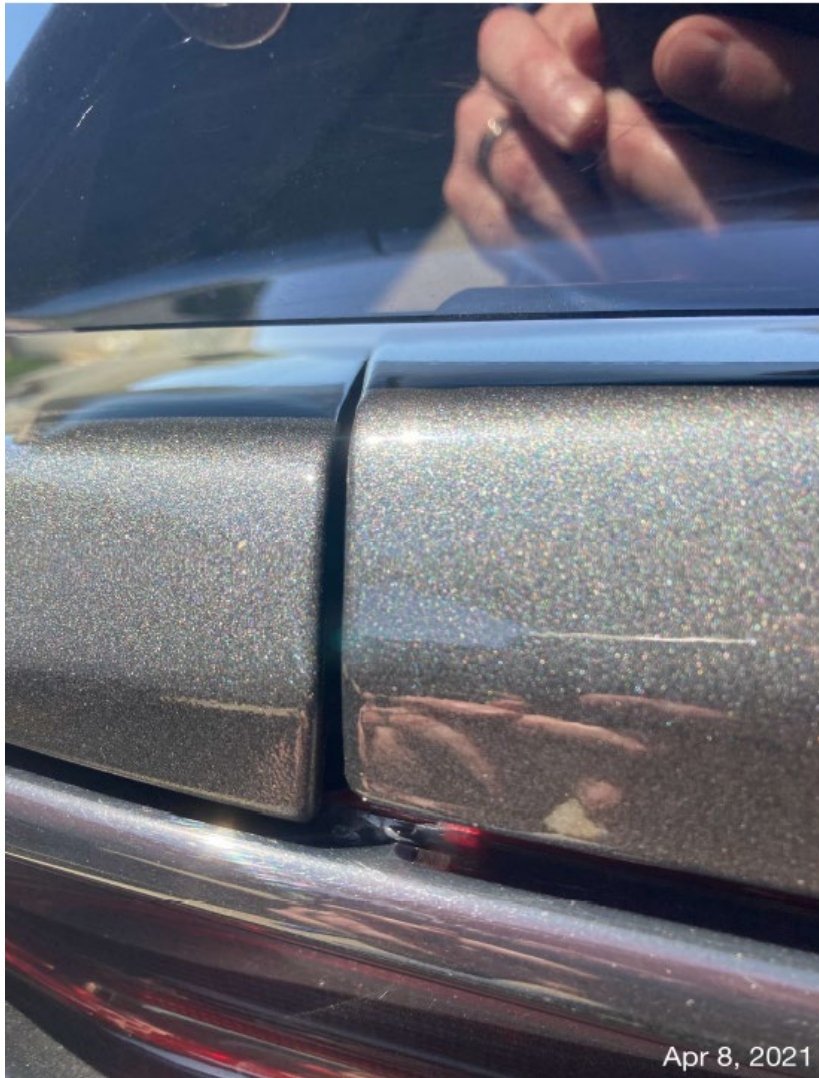
This photograph shows the left side of the trunk lid resting higher than the quarter panel when latched.

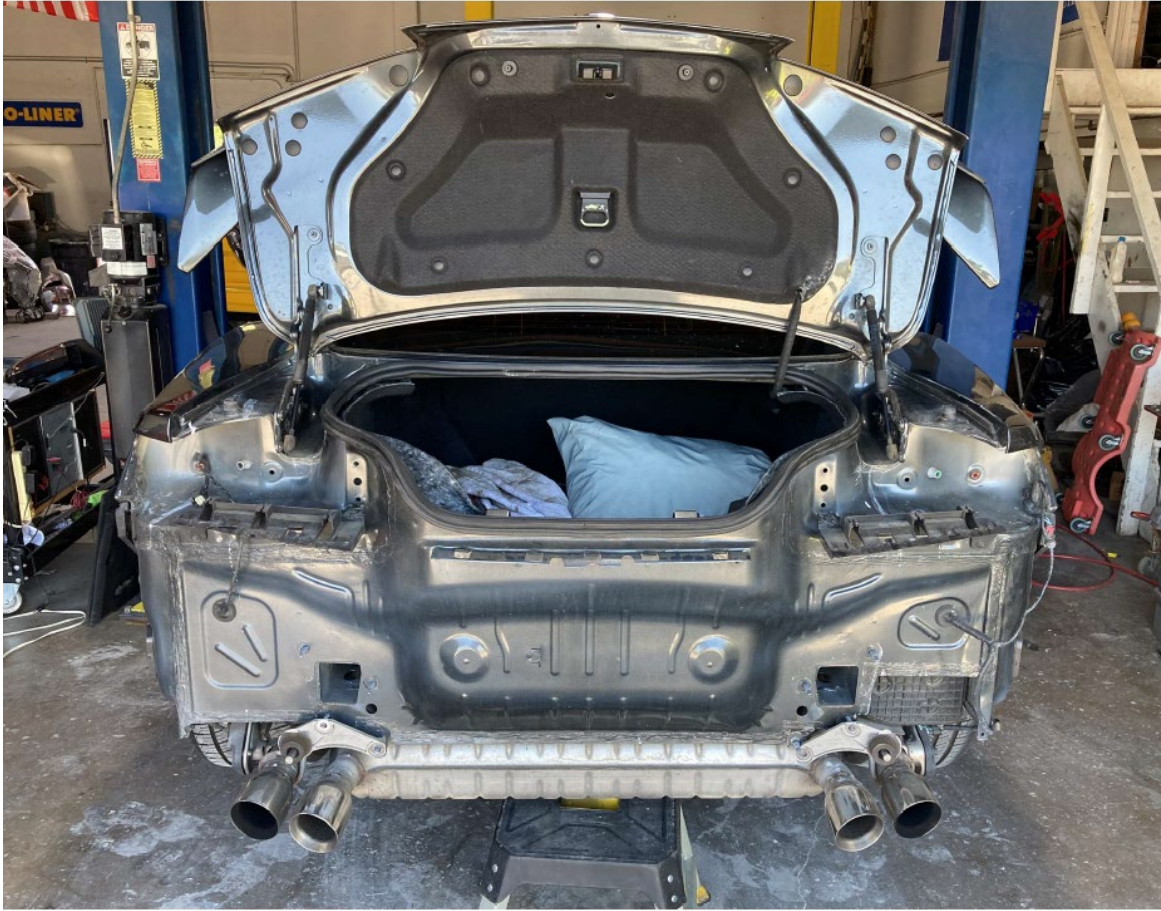
This photograph shows the rear section of the vehicle inspected with rear components removed.

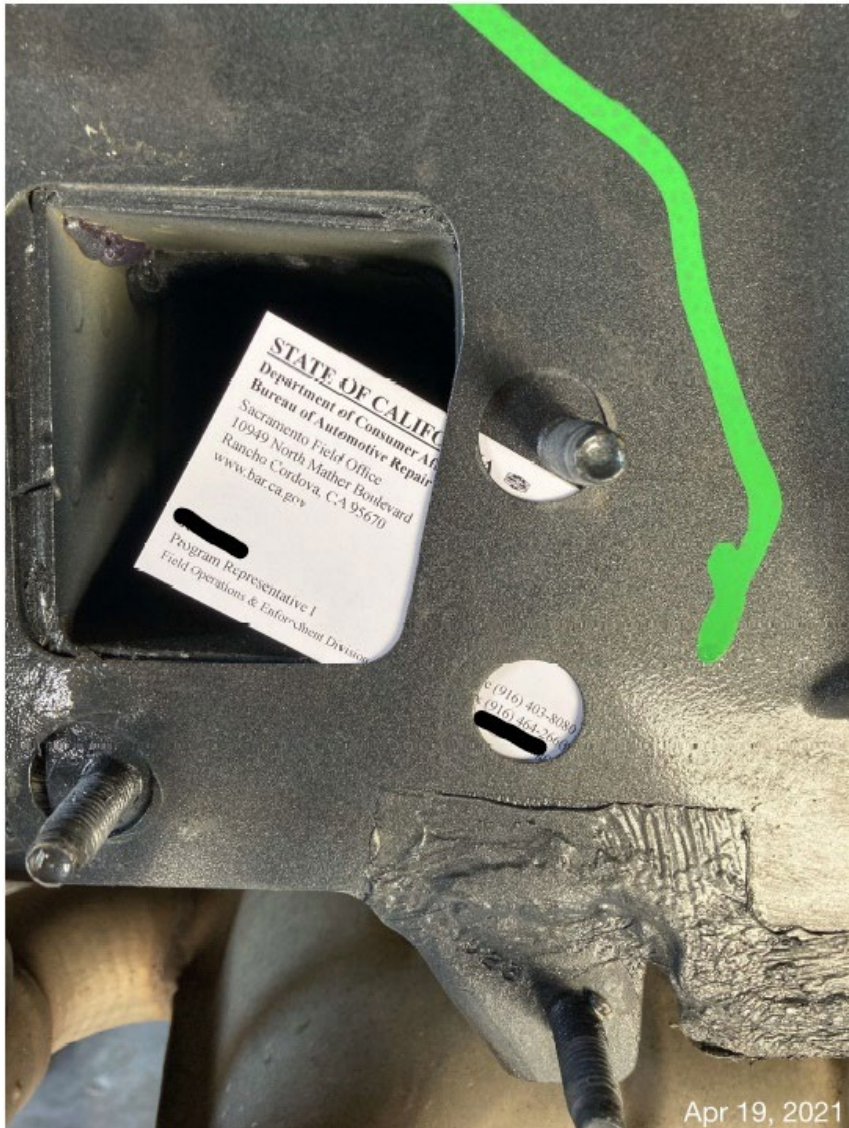
This picture shows a business card fitting between a mating section of the rear body panel and left frame rail end, which requires welding or weld bond.

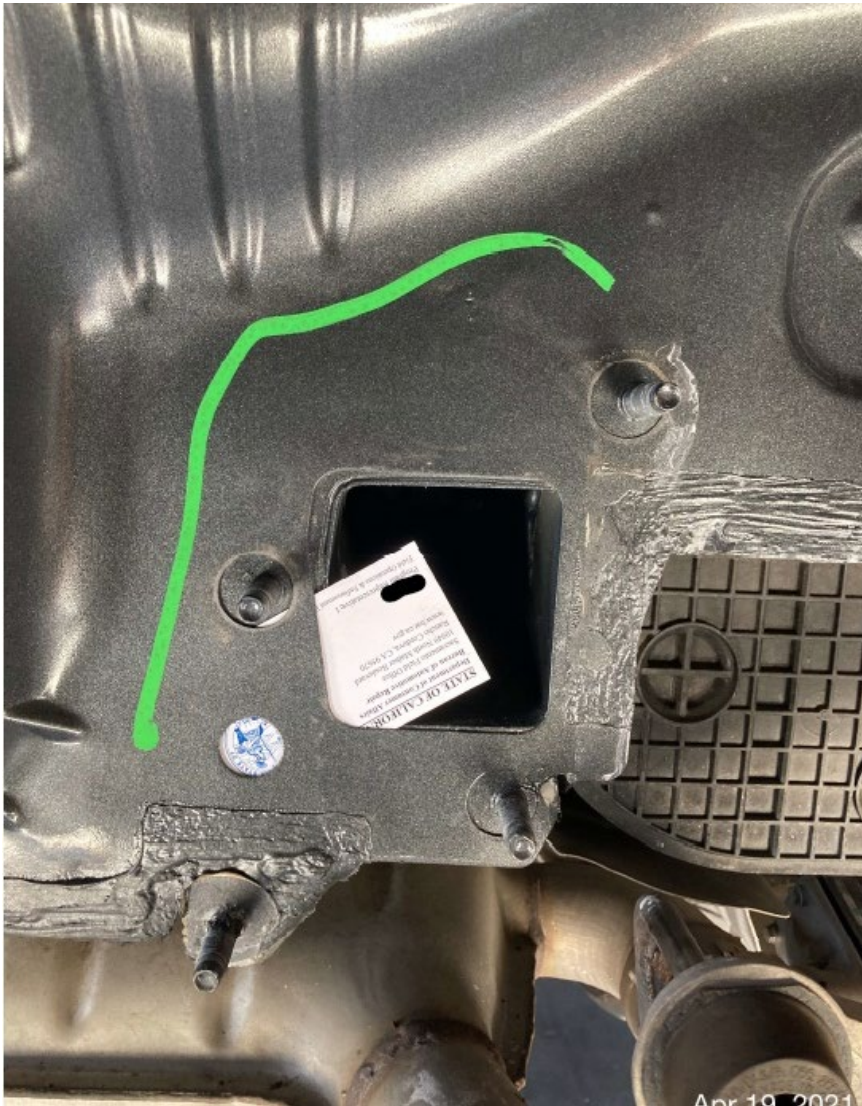
This picture shows a business card fitting between a mating section of the rear body panel and right frame rail end, which requires welding or weld bond

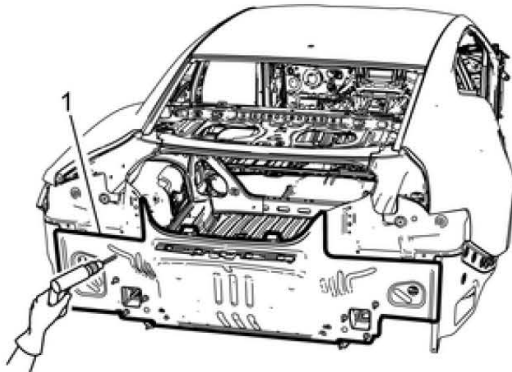
BODY REAR END PANEL REPLACEMENT (2 OF 3)

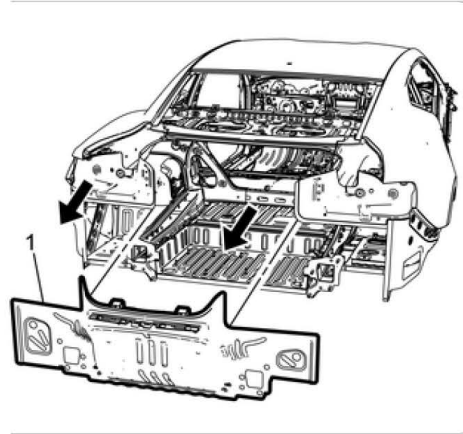
Installation Procedure

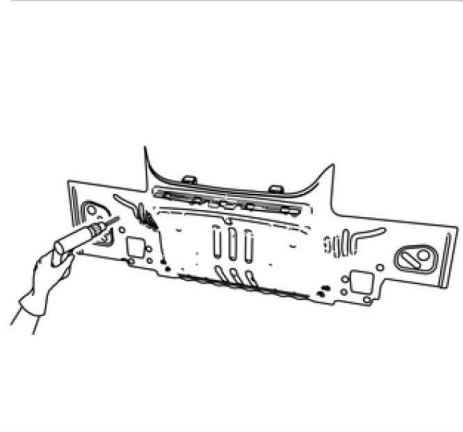
2. Apply Weld-Thru Coating or Panel bonding adhesive to all mating surfaces. Refer to Anti-Corrosion Treatment and Repair or Metal Panel Bonding.
3. Position the rear end panel on the vehicle. Use 3-dimensional measuring equipment to inspect the panel (1).

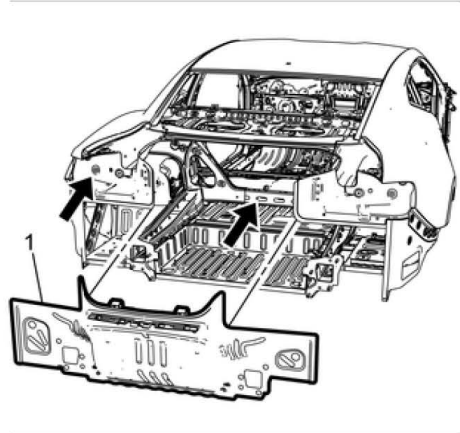
4. Weld or weld bond accordingly at the original weld locations (1).

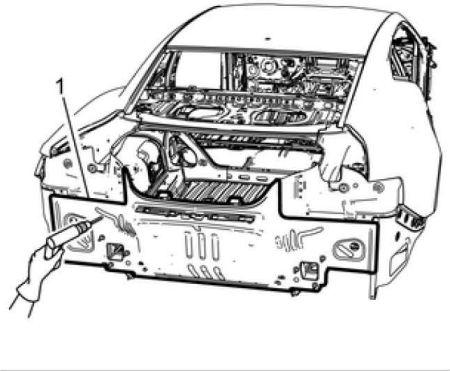
5. Clean all of the welded surfaces.
6. Apply the sealers and anti-corrosion materials to the repair area, as necessary. Refer to Anti-Corrosion Treatment and Repair.
7. Paint the repaired area. Refer to Basecoat/Clearcoat Paint Systems
8. Install all of the related panels and components.
9. Enable the SIR system and then connect the negative battery cable. Refer to SIR Disabling and Enabling.
